Test Report

Spacers cast concrete

M 0190 / 2015 | 31.04.2015 | english

Determination of the water penetration on concrete specimens with built-in spacers according to DIN 1048, Part 5 freeze-thaw test according to DIN CEN / TS 12390-9 via CDF test methods. Examination after thermal cycling

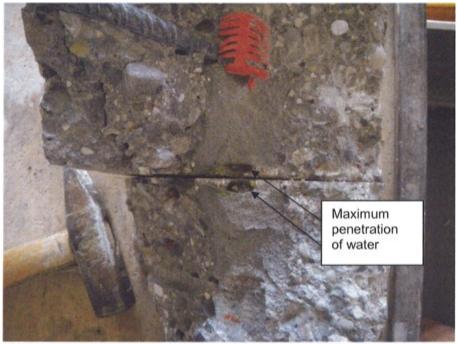
Picture 3: Sample 1 after splitting for measuring the depth of water penetration 5 mm

After cleavage, it was found that the samples have an average water penetration of about 0,3 cm. The maximum allowed penetration depth of 5 cm was not exceeded.

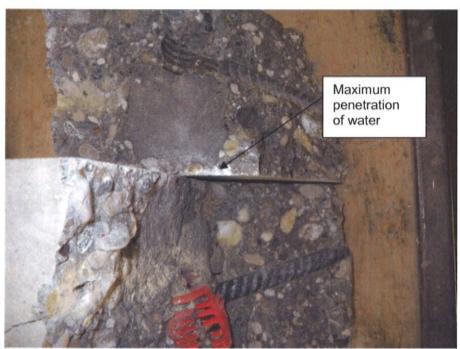
Picture 5 Sample 3 after splitting for measuring the depth of water 3 mm

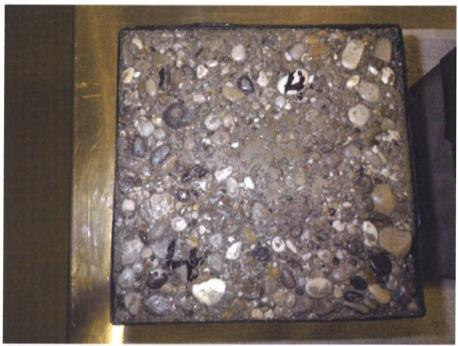
Picture 6: Sample 4 after 28 freeze thaw resistance, strong abgewitterte surface. No damage to the spacers.

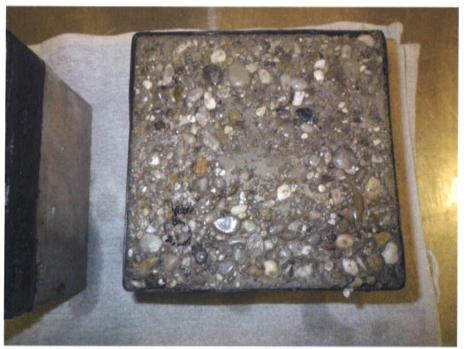
Picture 7: after 28 freeze thaw resistance, strong abgewitterte surface. No damage to the spacer regonizable

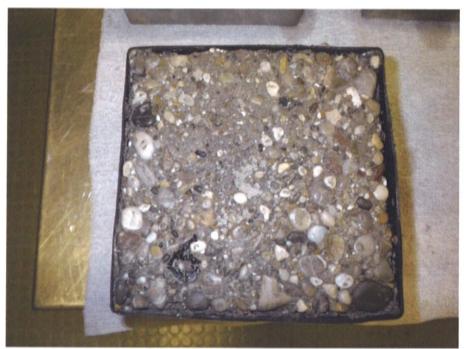
Picture 8: Test 6 after 28 freeze thaw resistance , strong abgewitterte surface. No damage to the spacer recognizable.
